# Pavement Asset Management Plan

## Town of Wheatfield

Last Updated: July 2018

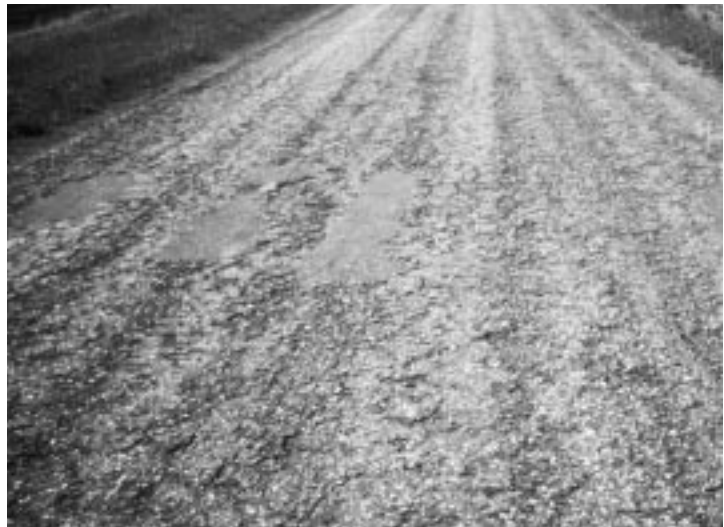
◀ Severe raveling and loss of surface material.

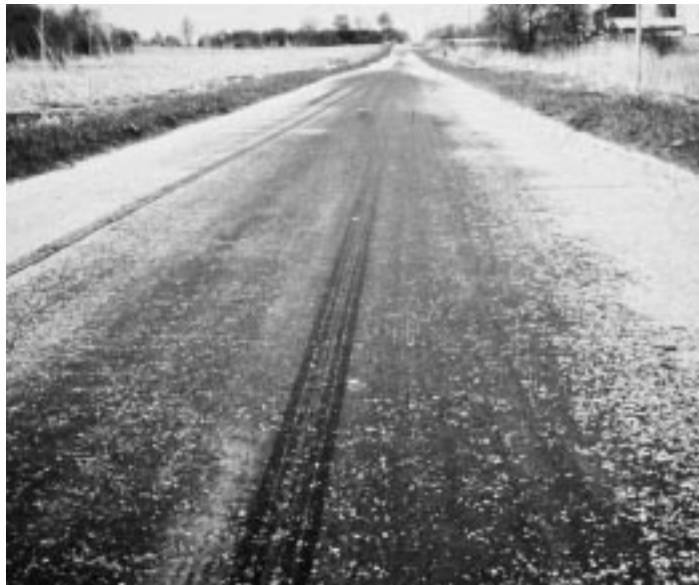
Polished, worn aggregate needs repair. ▼

Polishing is a smooth slippery surface caused by traffic wearing off sharp edges of aggregates. Repair with sealcoat or thin bituminous overlay using skid-resistant aggregate.

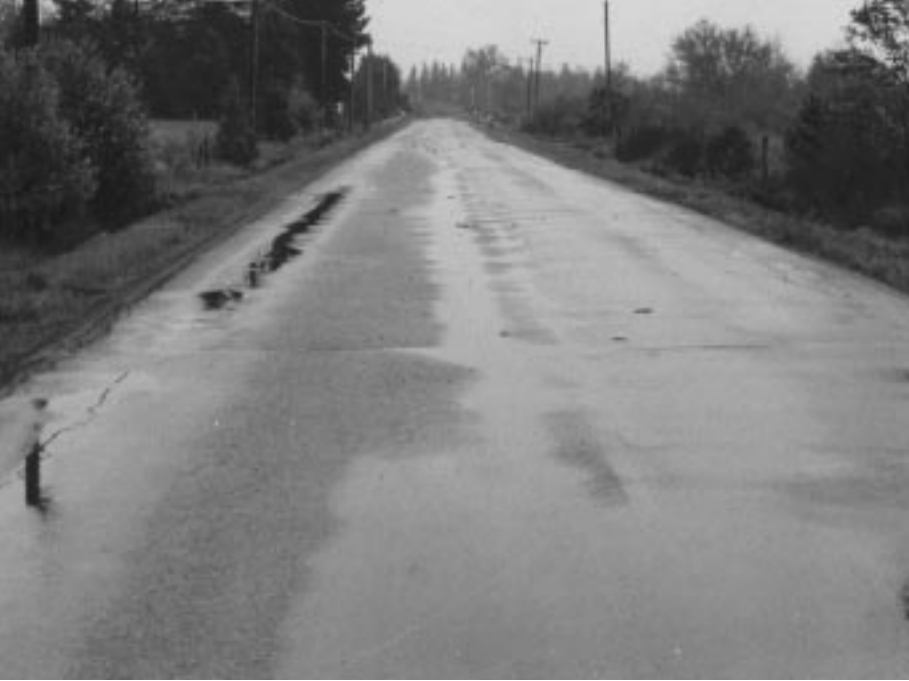
◀  
**Even slight rutting is evident after a rain.**

Rutting is displacement of material, creating channels in wheelpaths. It is caused by traffic compaction or displacement of unstable material. Severe rutting (over 2") may be caused by base or subgrade consolidation. Repair minor rutting with overlays. Severe rutting requires milling the old surface or reconstructing the roadbed before resurfacing.

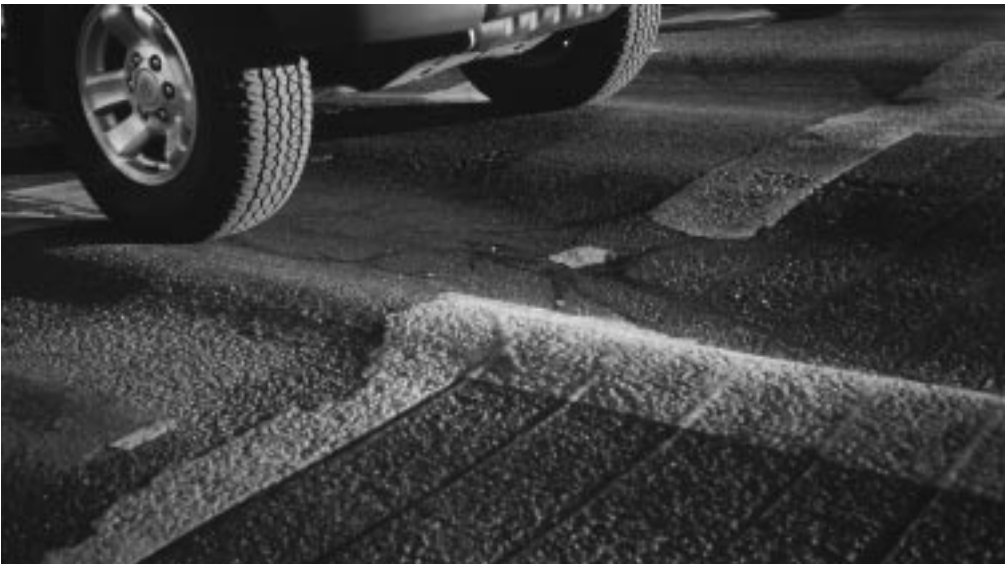
◀  
**Severe rutting over 2" caused by poor mix design.**

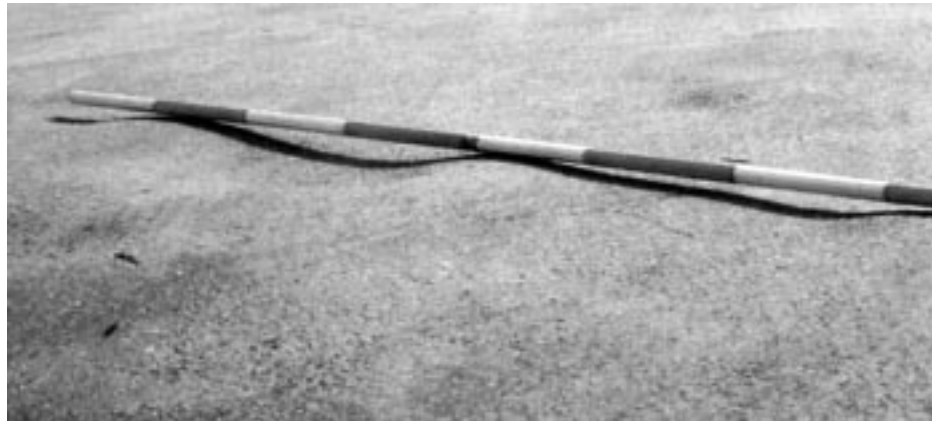
▼ Heavy traffic has shoved pavement into washboard ripples and bumps.

Shoving or rippling is surfacing material displaced crossways to the direction of traffic. It can develop into washboarding when the asphalt mixture is unstable because of poor quality aggregate or improper mix design. Repair by milling smooth and overlaying with stable asphalt mix.

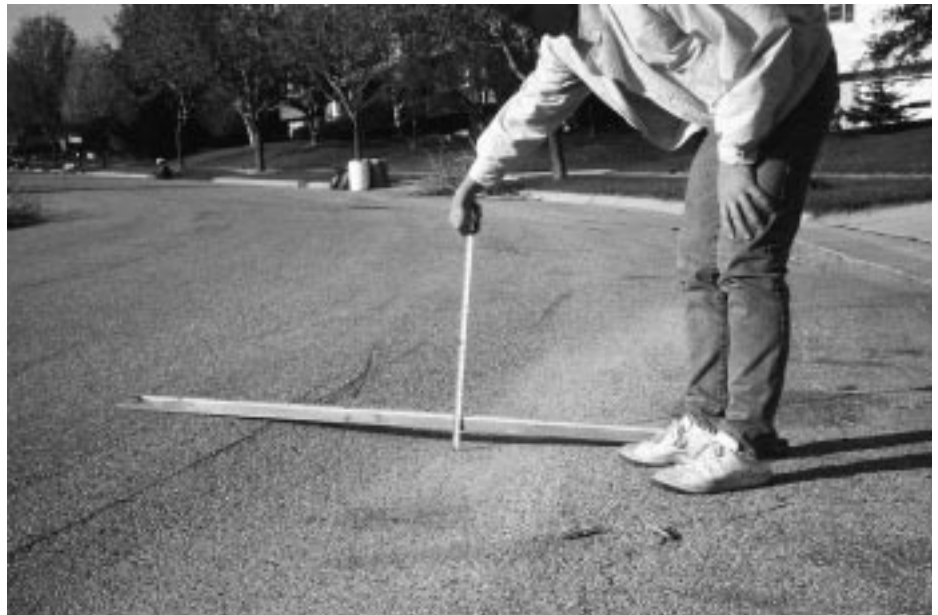
► Severe settling from utility trench.

Other pavement distortions may be caused by settling, frost heave, etc. Patching may provide temporary repair. Permanent correction usually involves removal of unsuitable subgrade material and reconstruction.

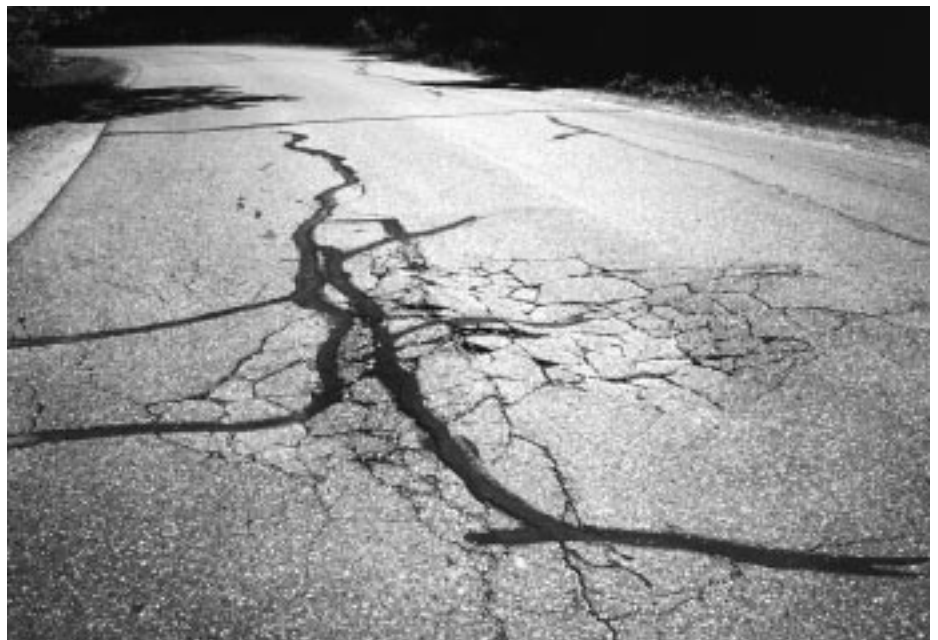
► Frost heave damage from spring break-up.

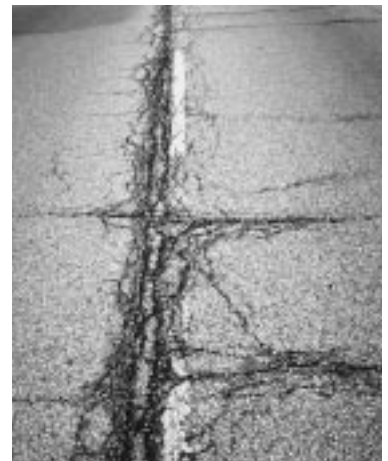
▲ Pavement ravel and erodes along open cracks causing deterioration.

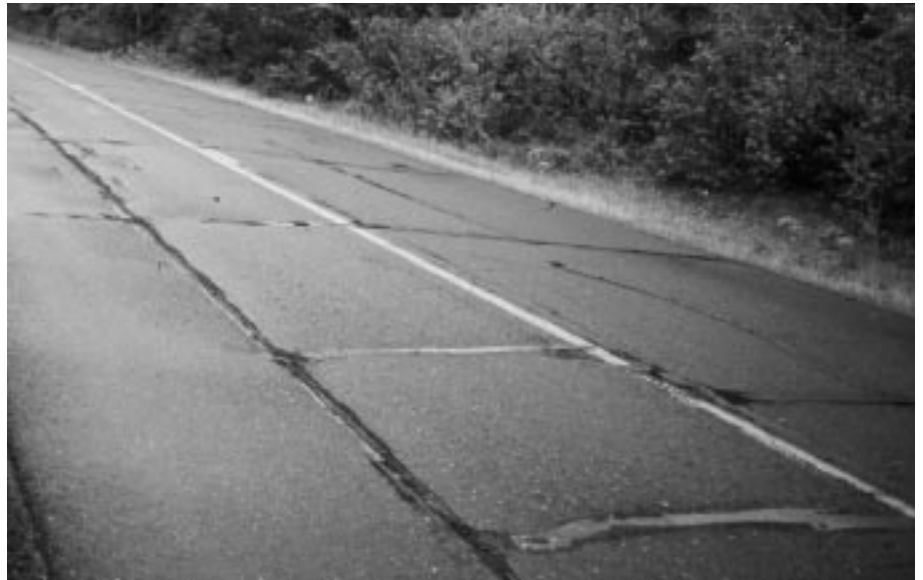
►  
**Concrete joints reflected through bituminous overlay.**

Cracks in overlays reflect the crack pattern in the pavement underneath. They are difficult to prevent and correct. Thick overlays or reconstruction is usually required.

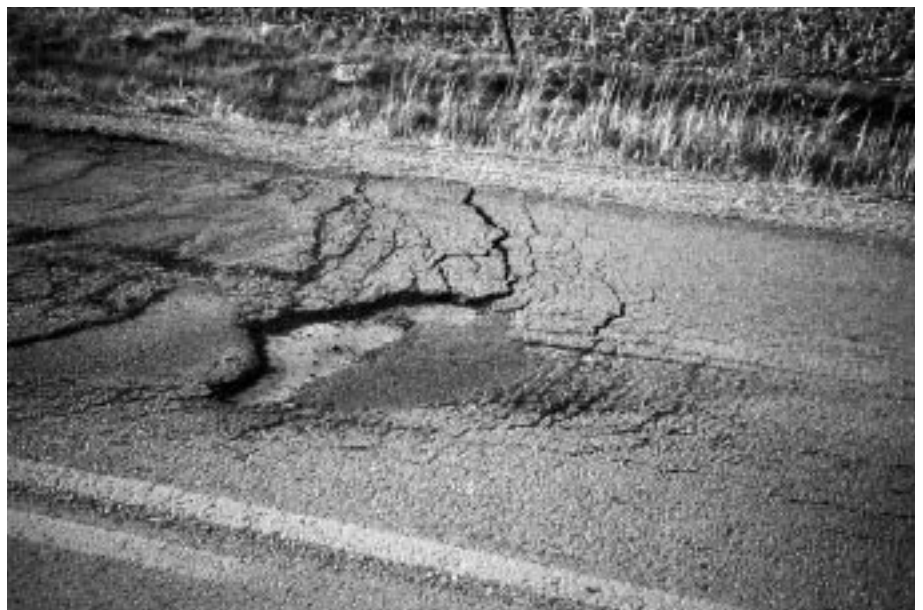
►  
**Loss of bond between pavement layers allows traffic to break loose pieces of surface.**

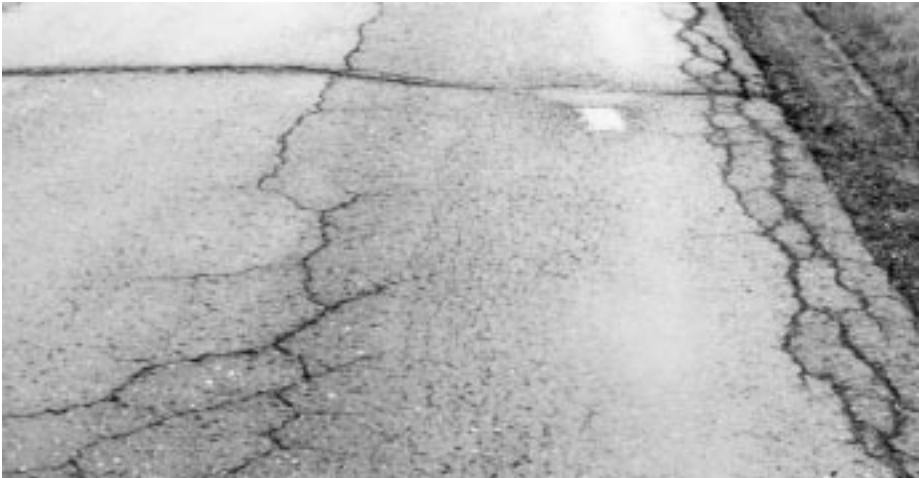
Edge cracking from weakened subbase and traffic loads. ▼

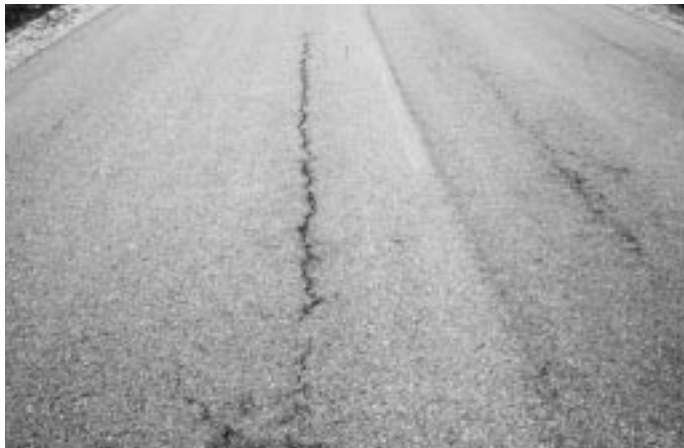
▶  
First stage of wheelpath cracking caused by heavy traffic loads.

Cracks running in the direction of traffic are longitudinal cracks. Center line or lane cracks are caused by inadequate bonding during construction or reflect cracks in underlying pavement. Longitudinal cracks in the wheel path indicate fatigue failure from heavy vehicle loads. Cracks within one foot of the edge are caused by insufficient shoulder support, poor drainage, or frost action. Cracks usually start as hairline or vary narrow and widen and erode with age. Without crack filling, they can ravel, develop multiple cracks, and become wide enough to require patching.

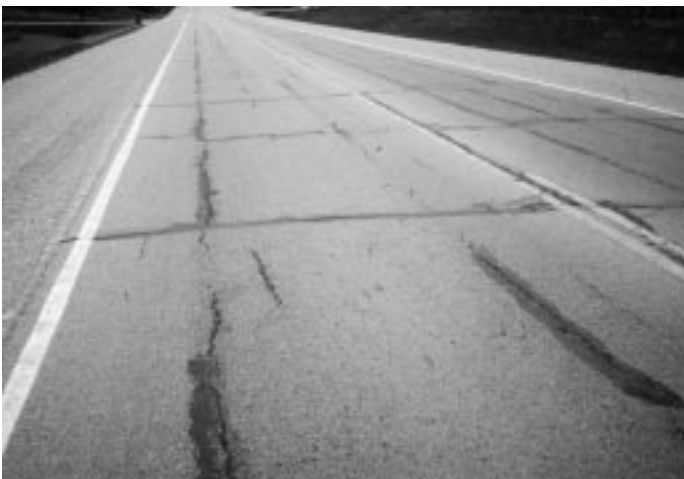
Load-related cracks in wheel path plus centerline cracking. ▼

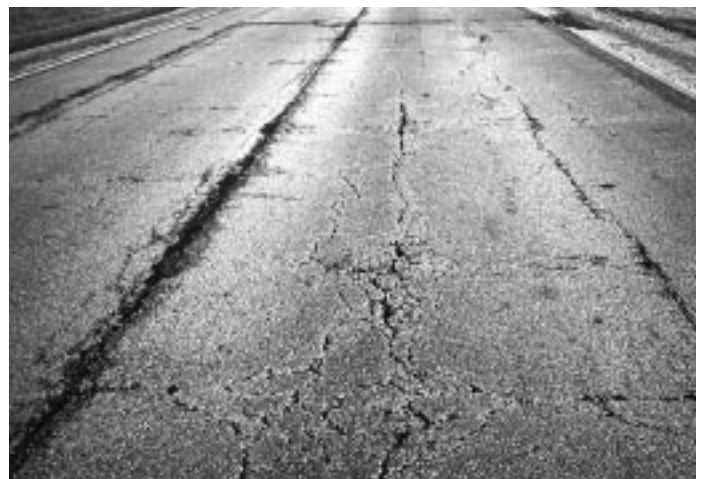
Multiple open cracks at center line, wheelpaths and lane center. ▼

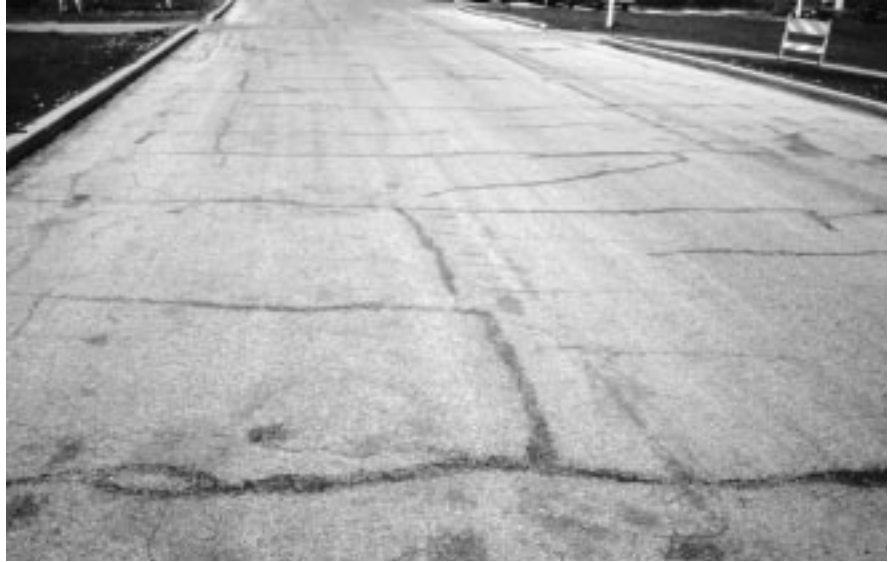
▶  
**Large blocks, approximately 10' across.**

Block cracking is interconnected cracks forming large blocks. Cracks usually intersect at nearly right angles. Blocks may range from one foot to approximately 10' or more across. The closer spacing indicates more advanced aging caused by shrinking and hardening of the asphalt over time. Repair with sealcoating during early stages to reduce weathering of the asphalt. Overlay or reconstruction required in the advanced stages.

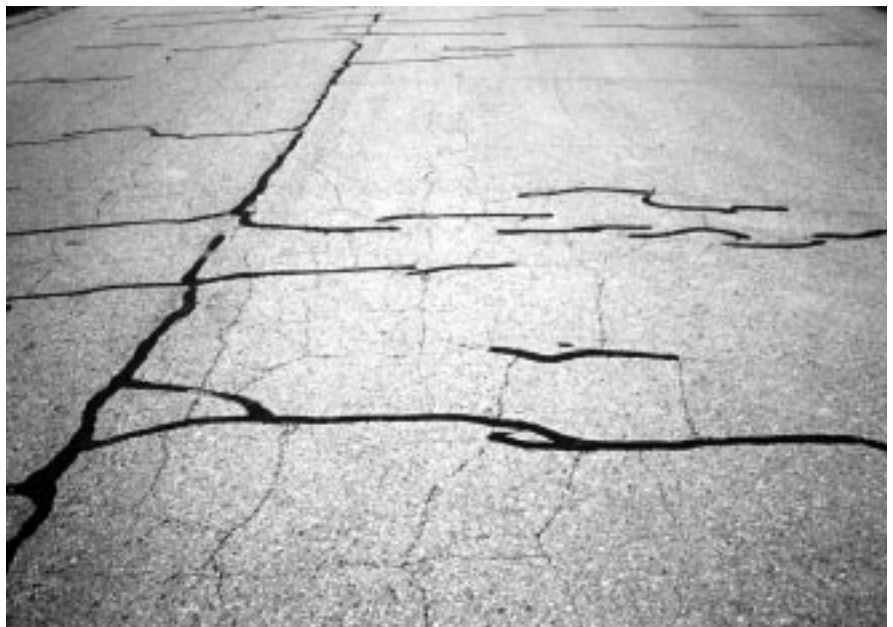
▶  
**Severe block cracking – 1' or smaller blocks. Tight cracks with no raveling.**

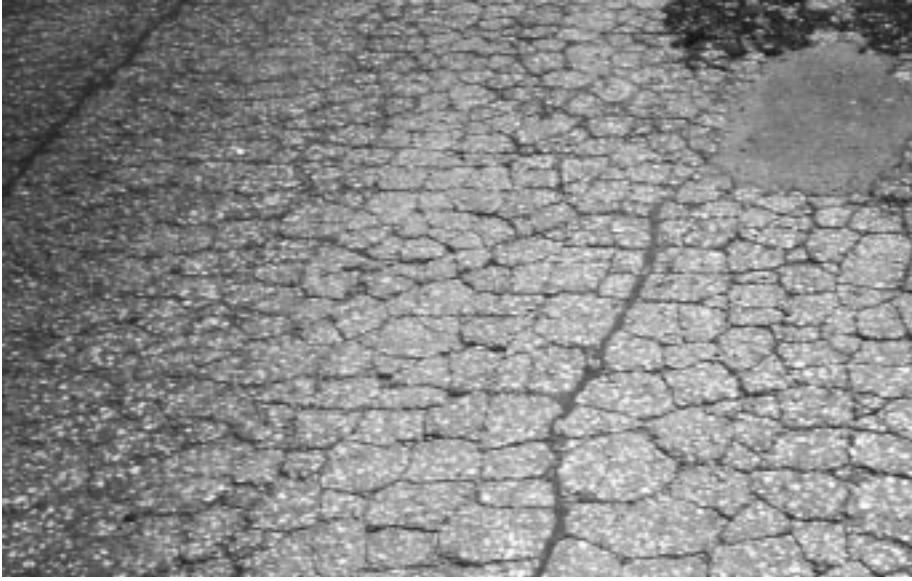
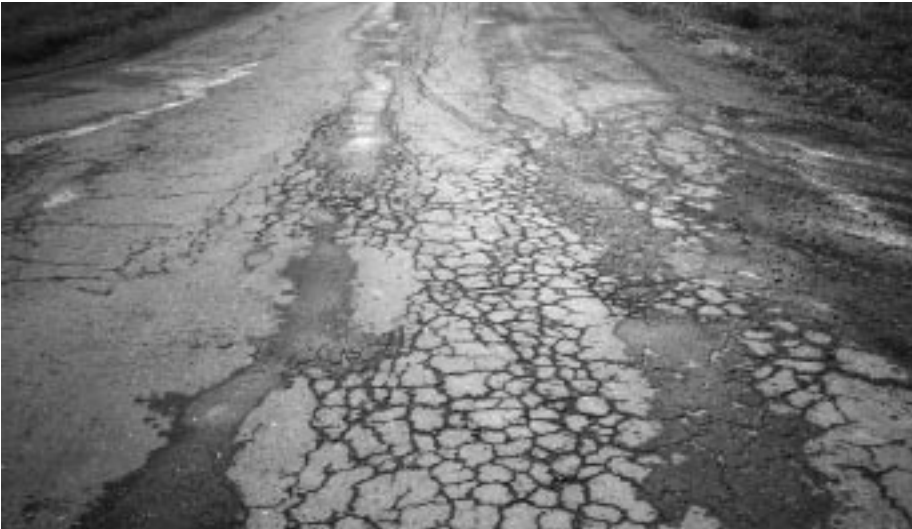
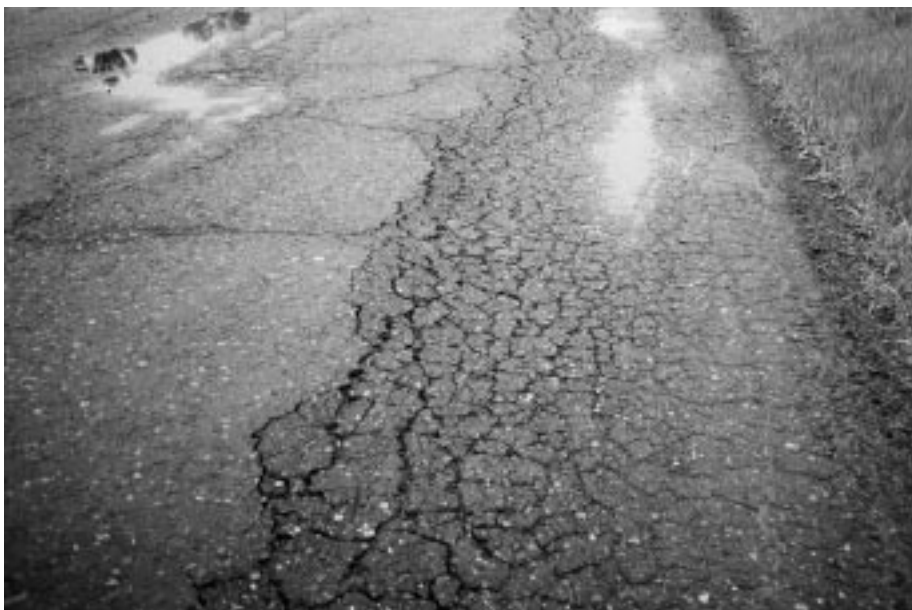
◀  
**Alligator crack pattern. Tight cracks and one patch.**

◀  
**Characteristic "chicken wire" crack pattern shows smaller pavement pieces and patching.**

◀  
**Open raveled alligator cracking with settlement along lane edge most likely due to very soft subgrade.**

Interconnected cracks forming small pieces ranging in size from about 1" to 6". This is caused by failure of the surfacing due to traffic loading (fatigue) and very often also due to inadequate base or subgrade support. Repair by excavating localized areas and replacing base and surface. Large areas require reconstruction. Improvements in drainage may often be required.

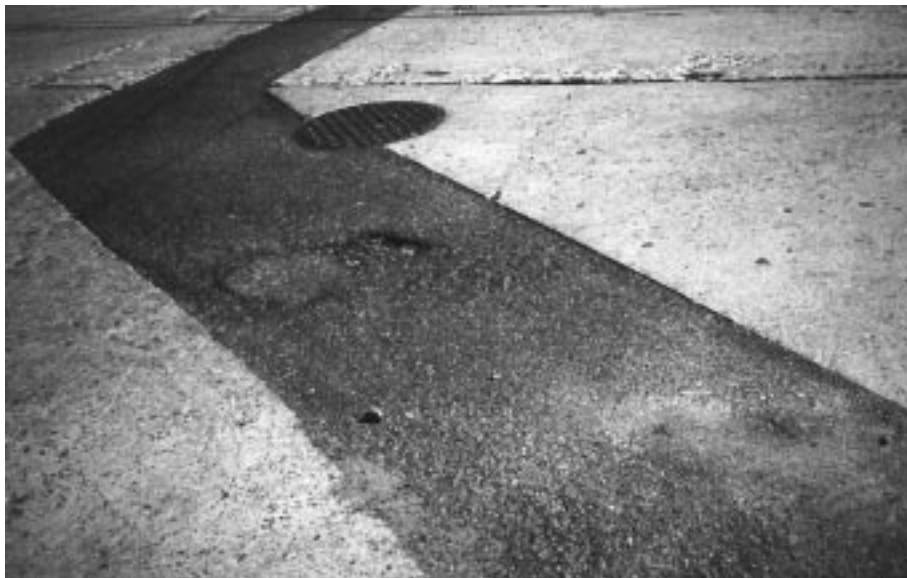
►  
**Typical repair of utility excavation. Patch in fair to good condition.**

Original surface repaired with new asphalt patch material. This indicates a pavement defect or utility excavation which has been repaired. Patches with cracking, settlement or distortions indicate underlying causes still remain. Recycling or reconstruction are required when extensive patching shows distress.

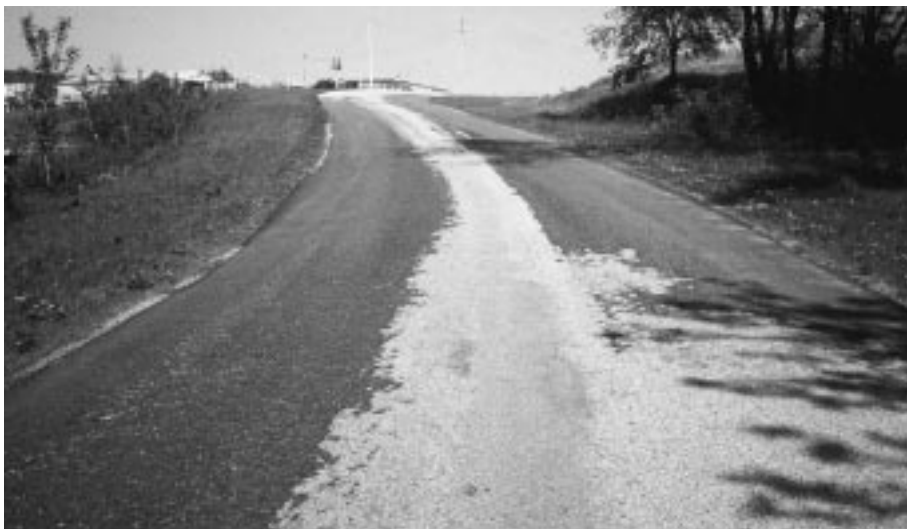
►  
**Edge wedging. Pavement edges strengthened with wedges of asphalt. Patch is in very good condition.**

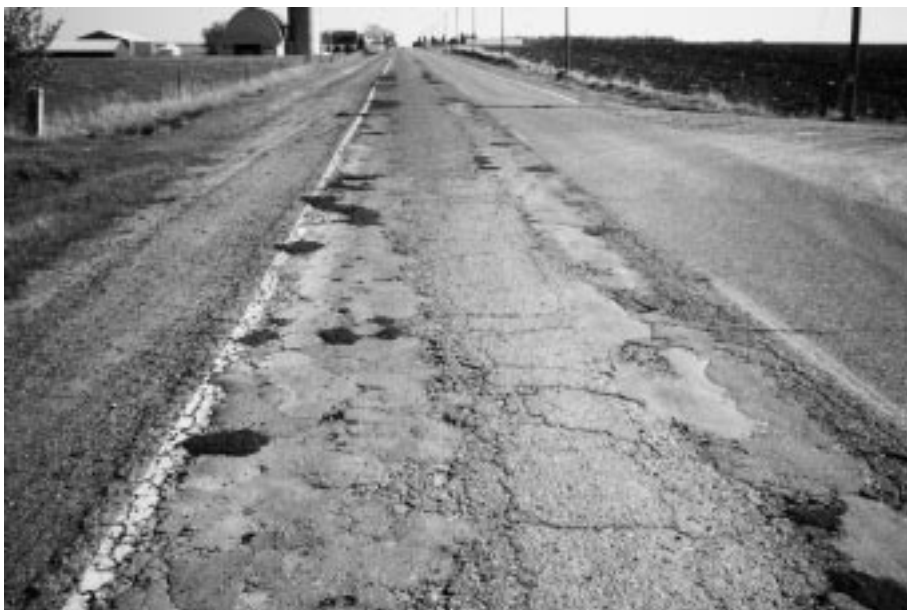
►  
**Extensive patching in very poor condition.**

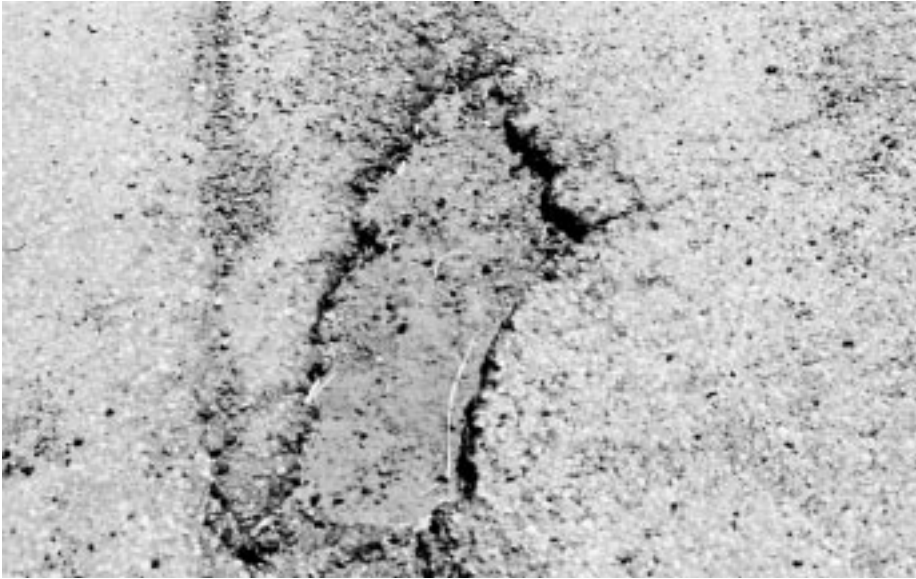
◀  
**Small pothole where top course has broken away.**

Holes and loss of pavement material caused by traffic loading, fatigue and inadequate strength. Often combined with poor drainage. Repair by excavating or rebuilding localized potholes. Reconstruction required for extensive defects.

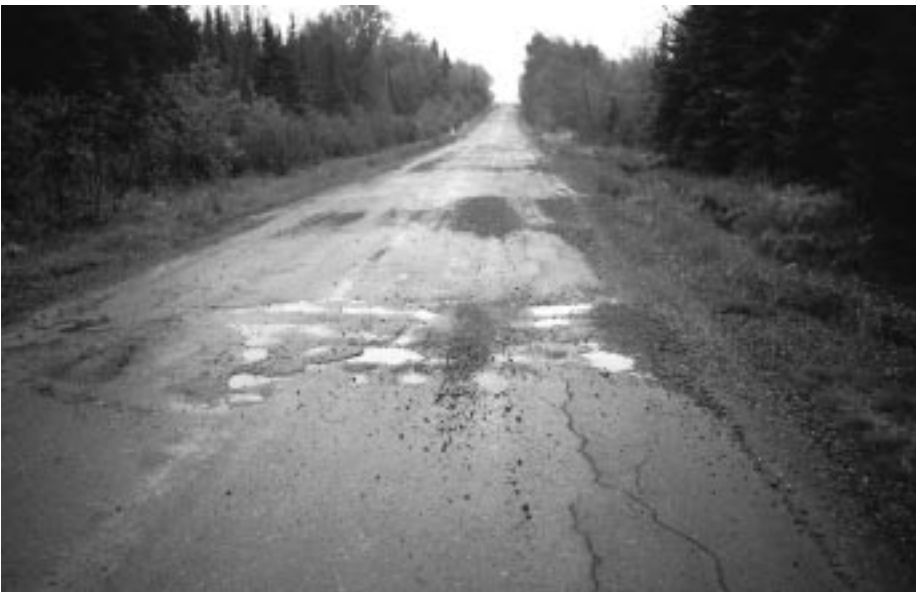
◀  
**Multiple potholes show pavement failure, probably due to poor subgrade soils, frost heave, and bad drainage.**

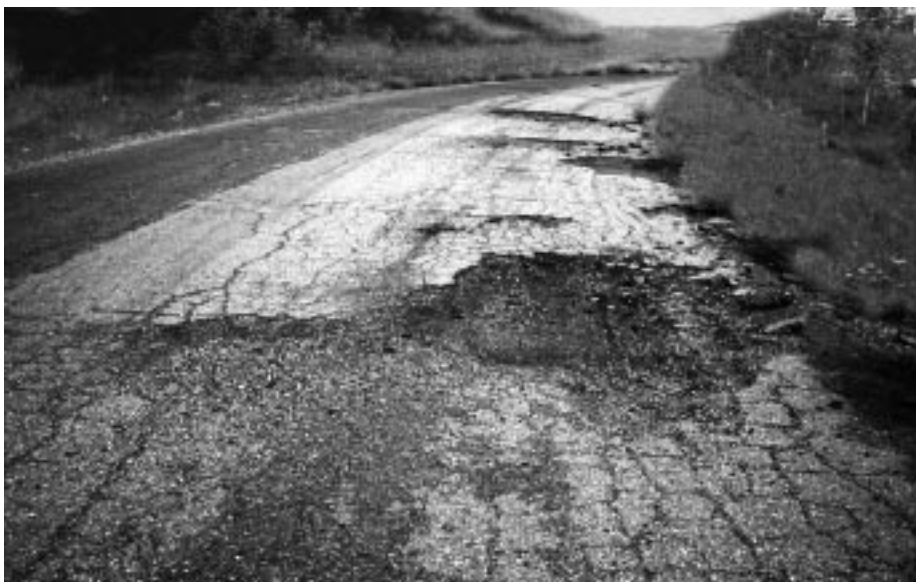
◀  
**Large, isolated pothole, extends through base. Note adjacent alligator cracks which commonly deteriorate into potholes.**

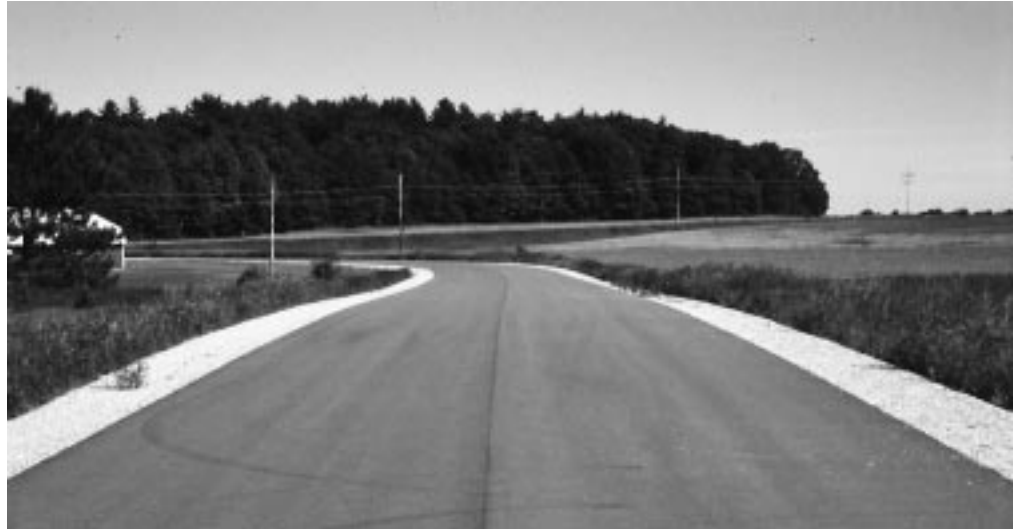
▶  
**RATING 10**  
New construction.

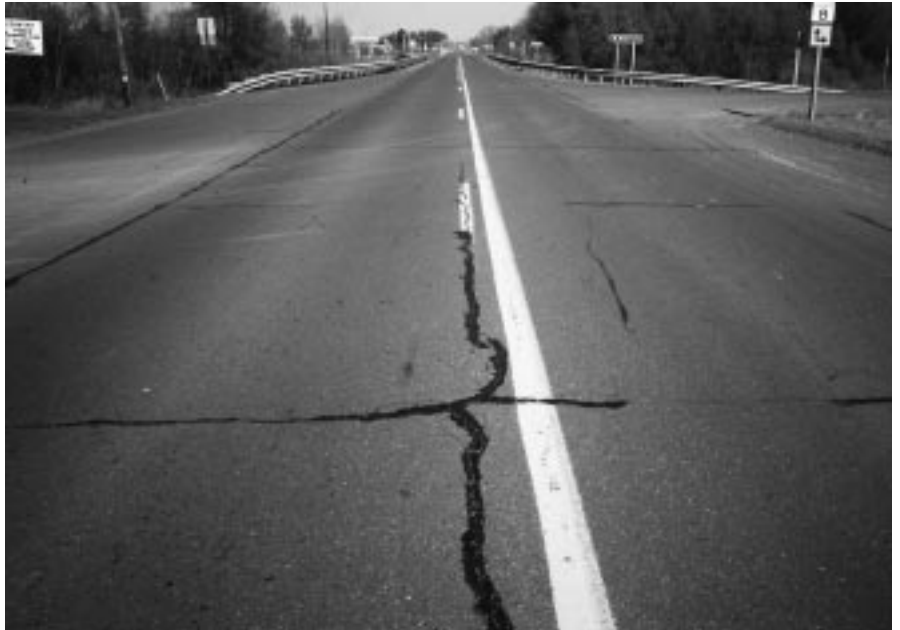
►  
**Tight and sealed  
transverse and  
longitudinal cracks.  
Maintain crack  
sealing program.**

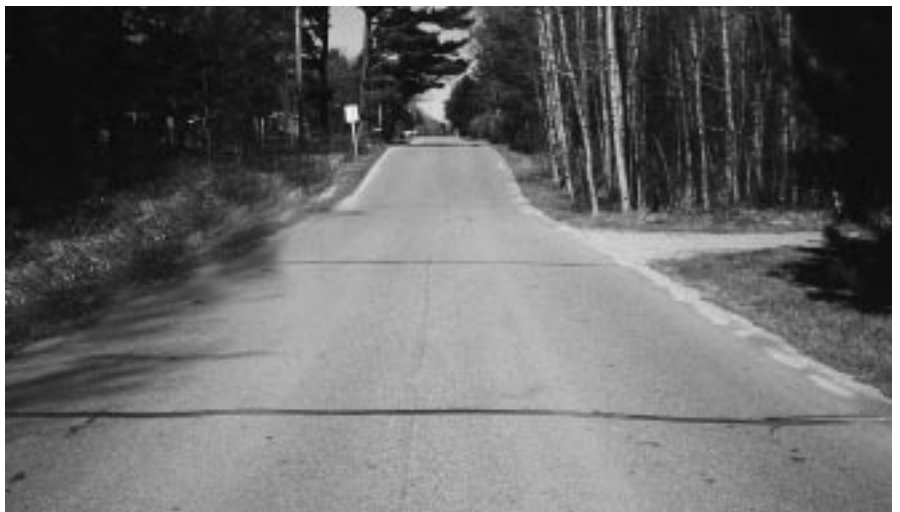
►  
**Tight and sealed  
transverse and  
longitudinal cracks.**

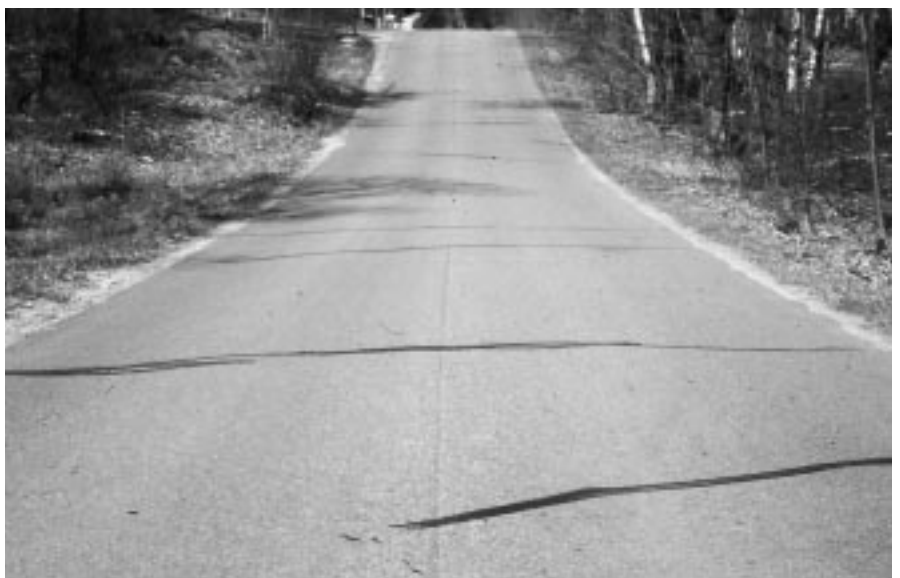
►  
**Transverse cracks  
about 10' or more  
apart. Maintain crack  
sealing program.**

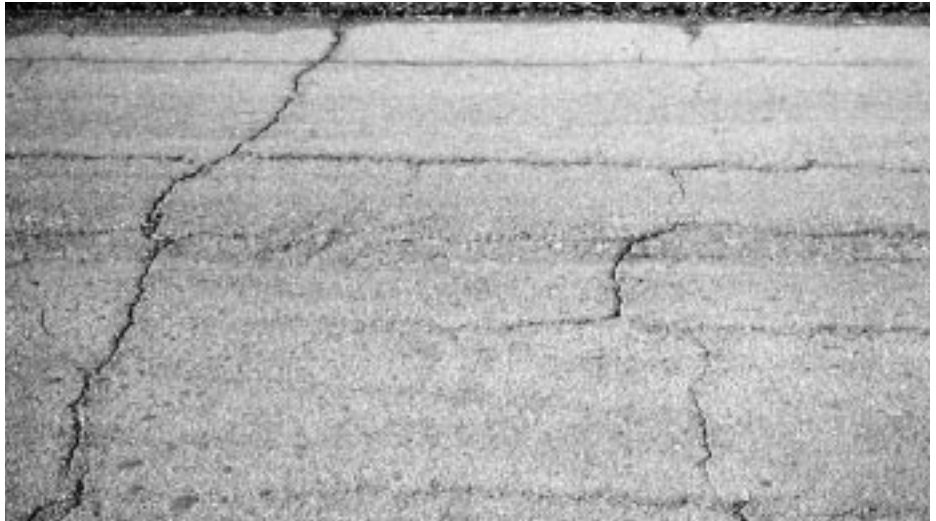
▼ Block cracking with open cracks.

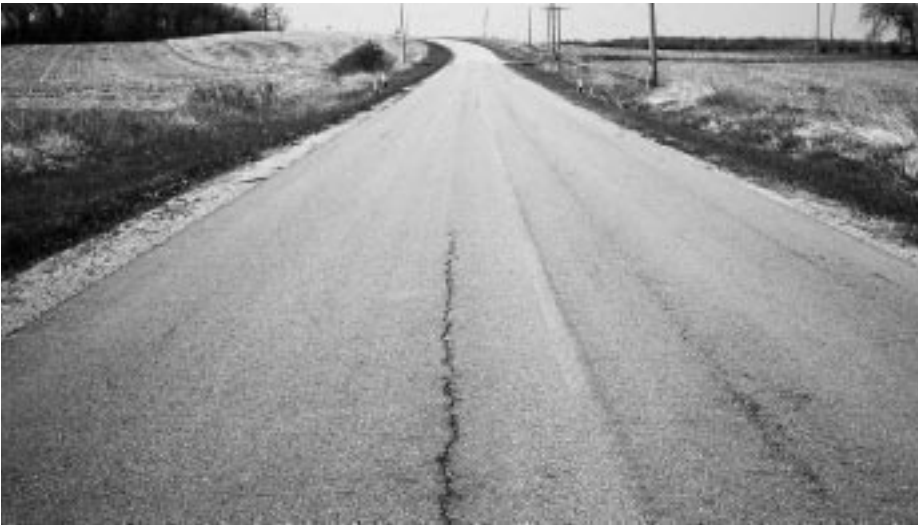
◀ **Longitudinal cracking; early load-related distress in wheel path. Strengthening needed.**

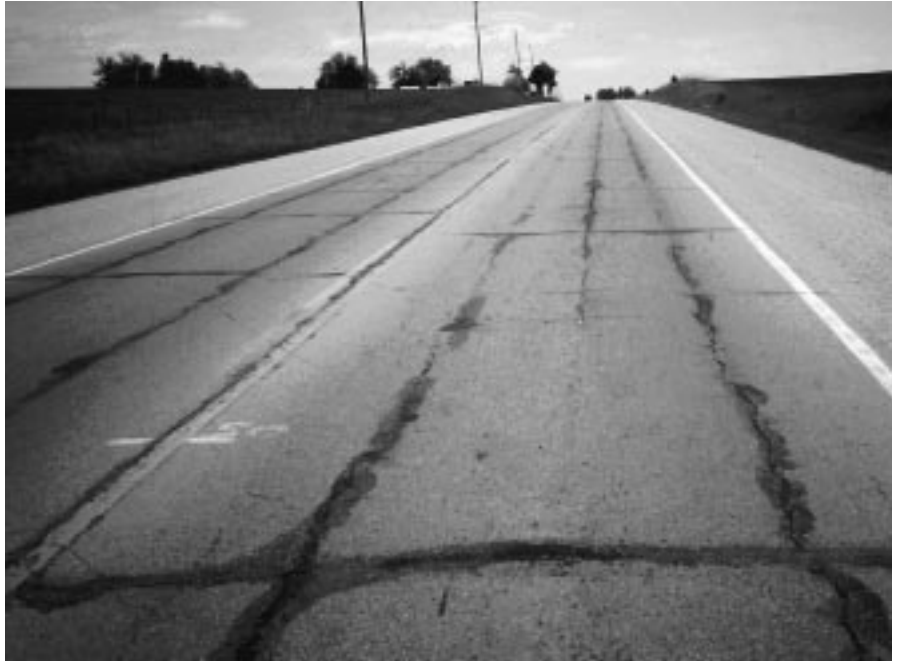
►  
**Many wide and raveled cracks indicate need for milling and overlay.**

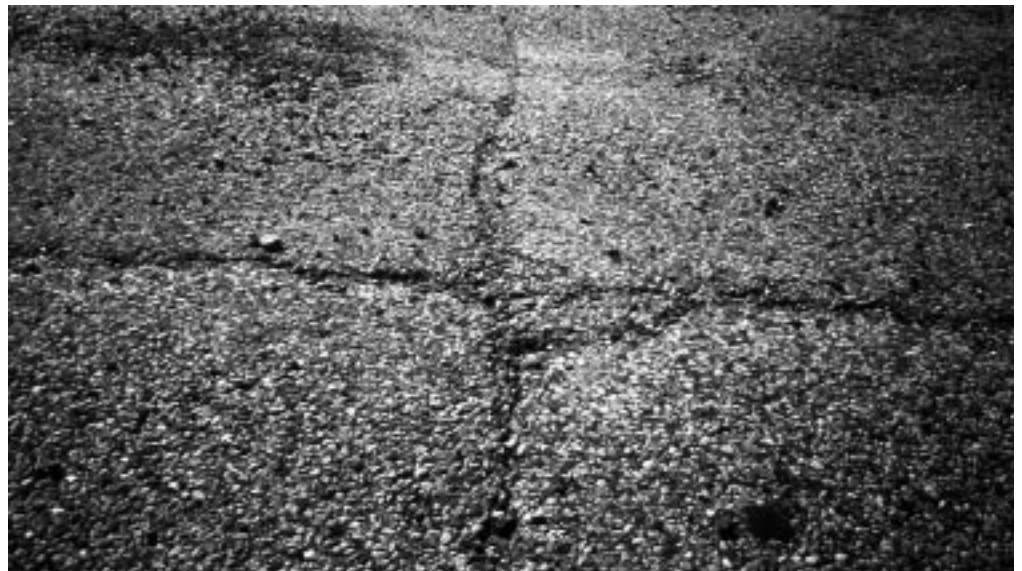
►  
**Open and raveled block cracks.**

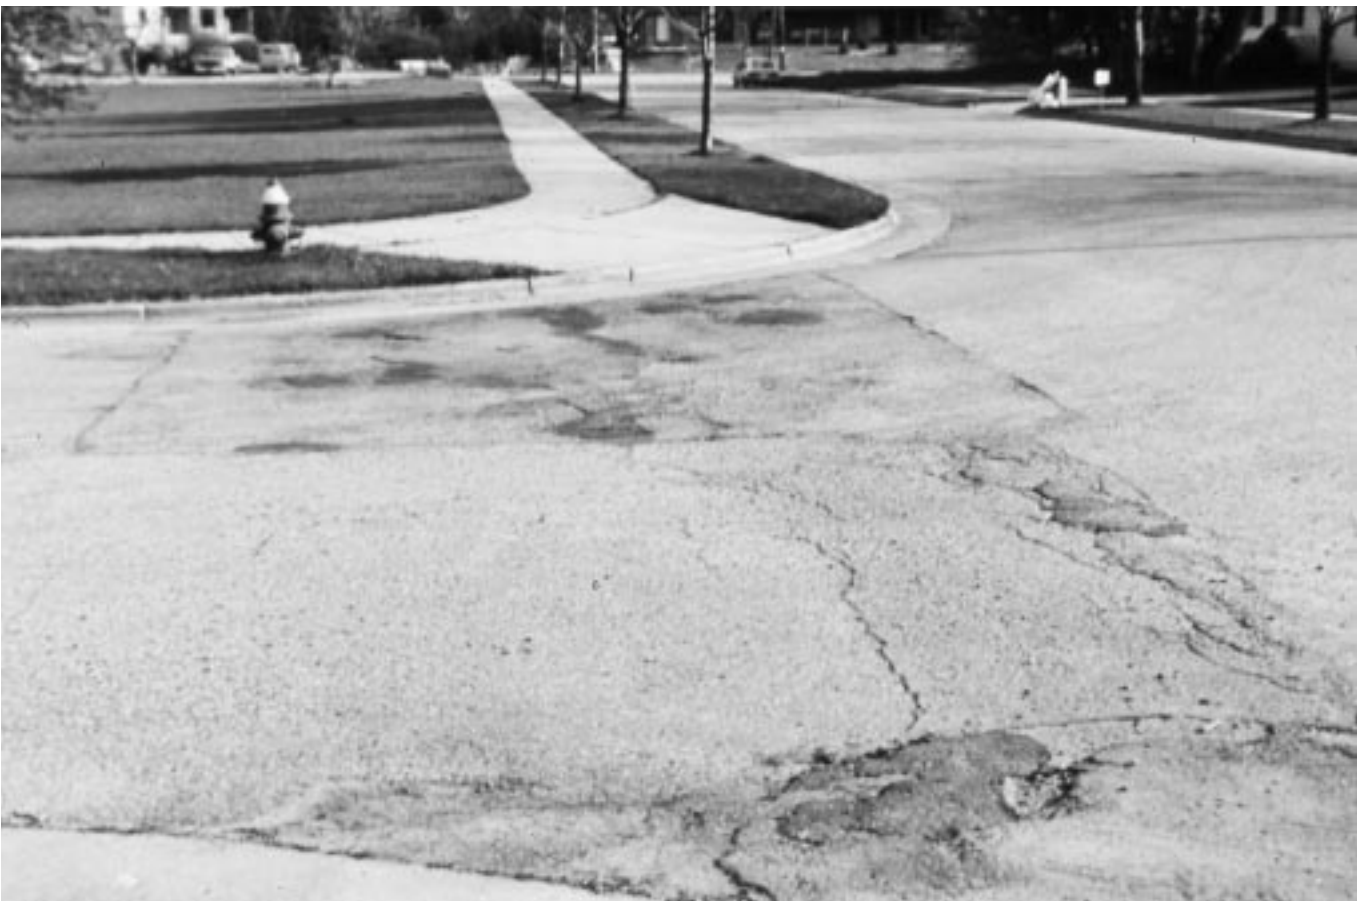
▼ **Distortion with patches**  
in poor condition. Repair  
and overlay.

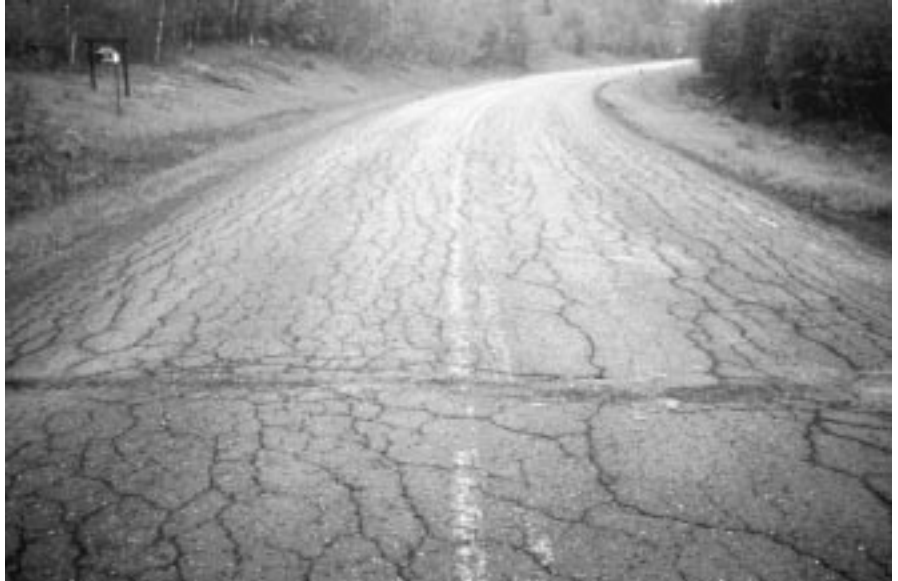
▶  
**Extensive alligator cracking. Pulverize and rebuild.**

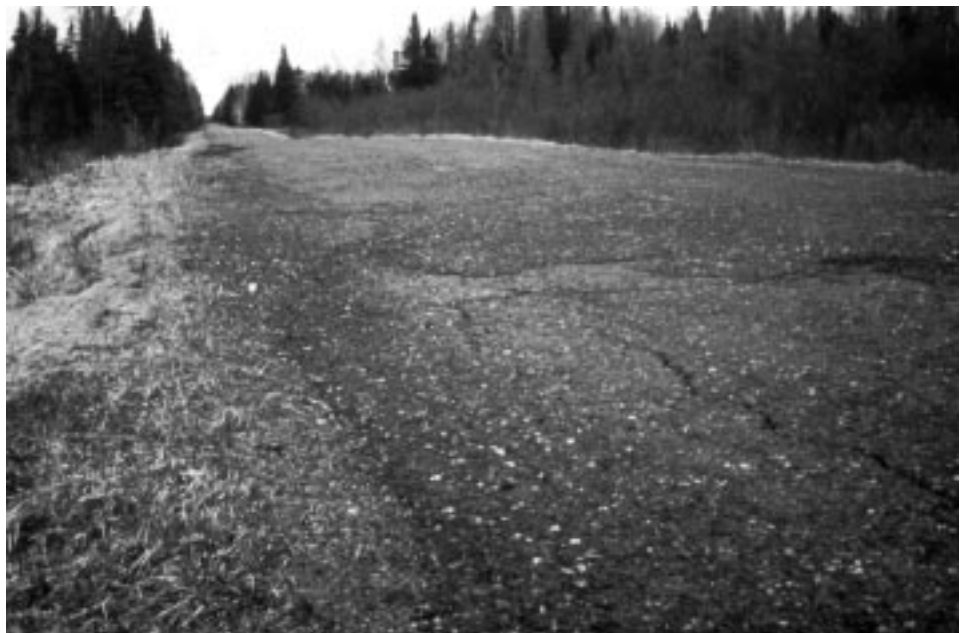
▶  
**Severe frost damage. Reconstruct.**

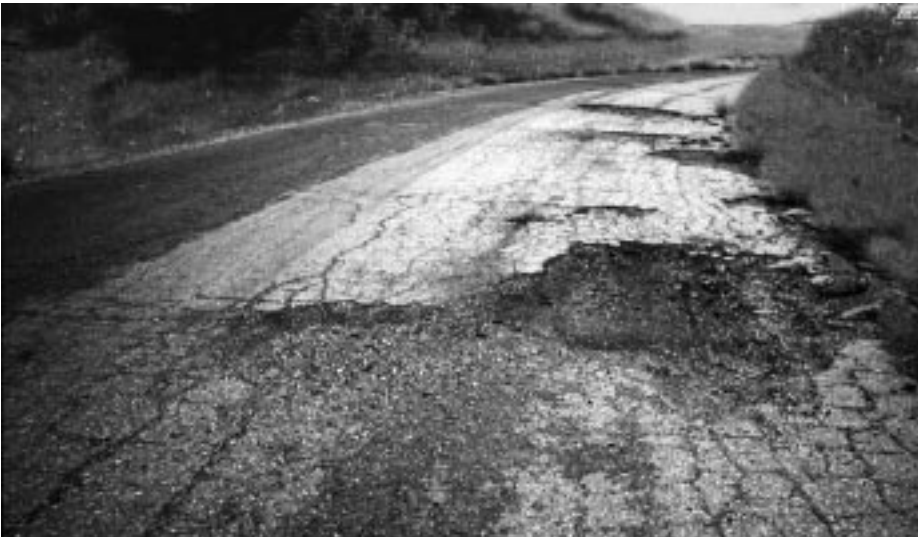
**Potholes and severe alligator cracking. Failed pavement. Reconstruct.**

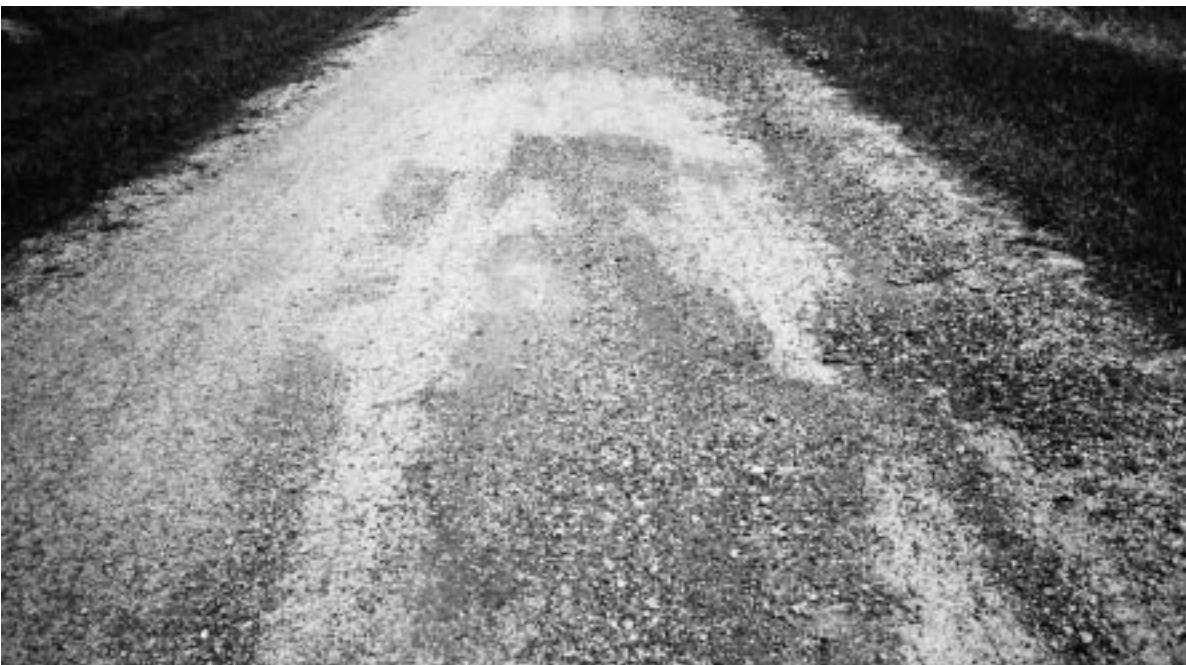
**Extensive loss of surface. Rebuild.**

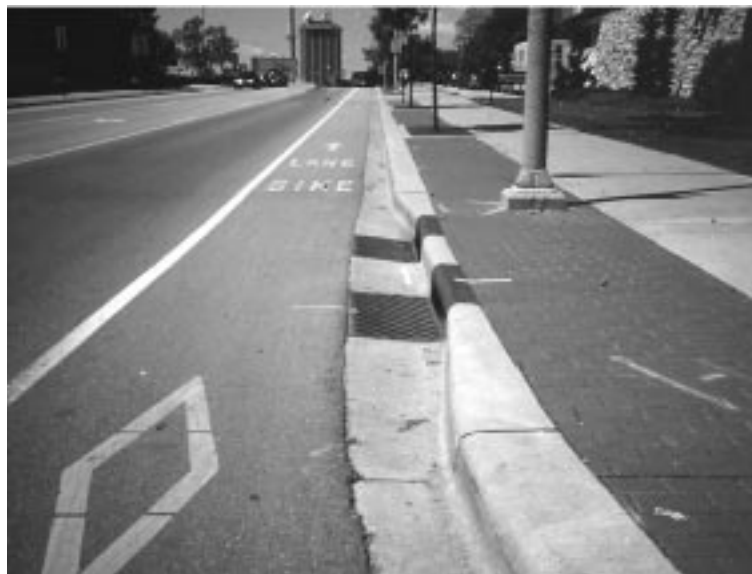
**Urban drainage.**  
**RATING:**  
**Excellent**

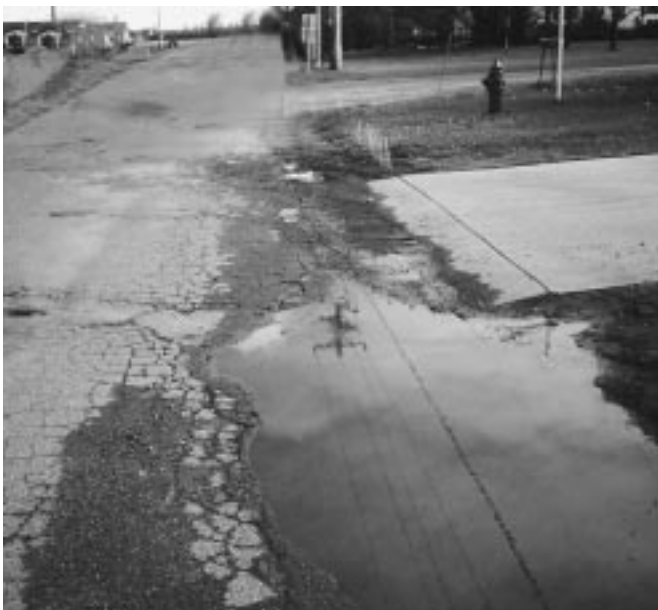
No drainage leads to failed pavement.

RATING: Poor
